Pre-Purchase Survey

S/Y "Lion's Shade"

44' Nauticat Motorsailer

Condition and Valuation Survey (Pre-Purchase)

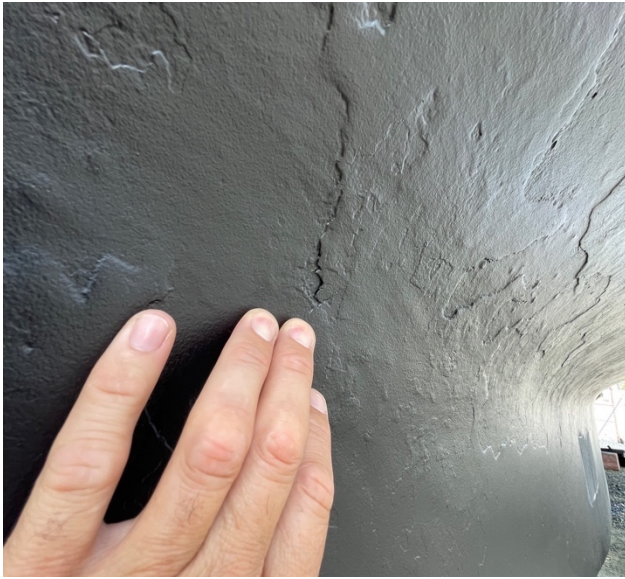
- “Haloing” of the anti-foul coatings was noted throughout hull surfaces on previous inspection **(See Recommendations B13)**.
- Anti-foul coatings showed multiple layers of previous coatings, recently renewed, See Photos.

IMG_2504 – Previous layers of anti-foul coatings.

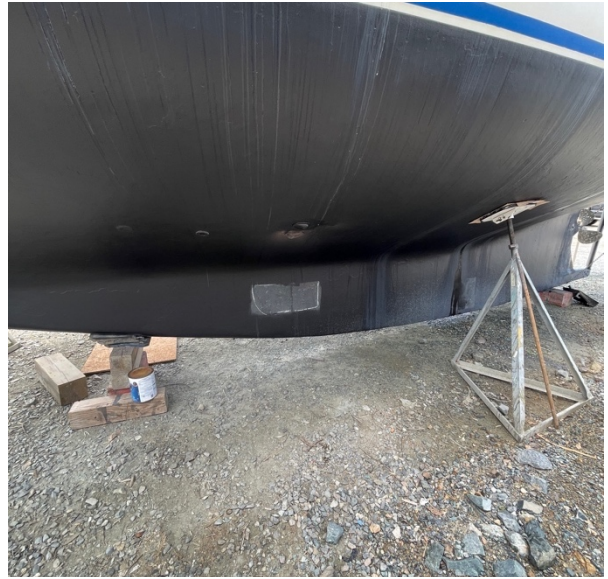
- Two (2) areas at the port keel sides were noted to sound as areas of concern during percussion testing with phenolic mallet. One (1) area at the starboard keel side was noted to sound as an area of concern during percussion testing with phenolic mallet. The area was outlined in chalk for identification **(See Recommendations B10).**
- Several small quarter sized previously ruptured blisters were noted in the port forward bow area **(See Recommendations B11).**
- The fairing at the aft of the keel supporting the shaft log was cosmetically imperfect and the entire section sounded as an area of concern during percussion testing with phenolic mallet. The area had not been covered in anti-foul coatings and showed a crack at the upper starboard edge **(See Recommendations B12).** See Photo: IMG_2516.

IMG_2505 – Port keel area of concern.

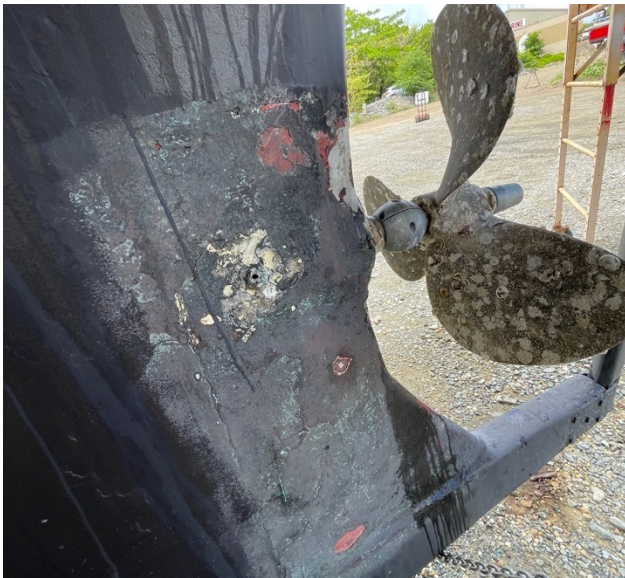
IMG_2509 – Fairing to port aft of keel in way of propeller shaft.

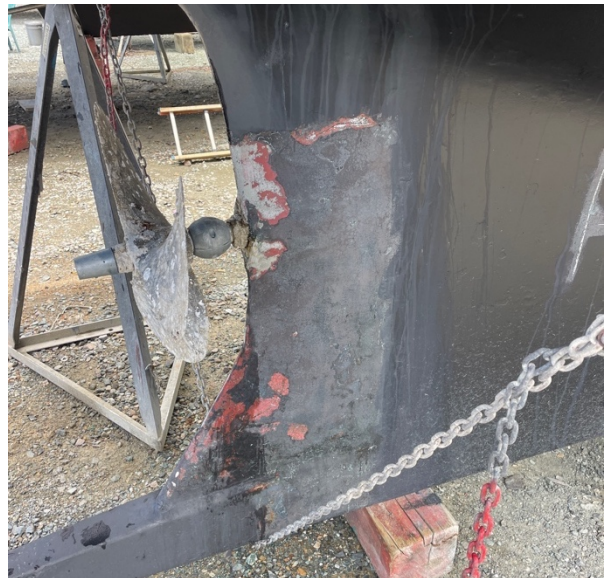
IMG_2515 – Fairing to starboard aft of keel in way of propeller shaft.

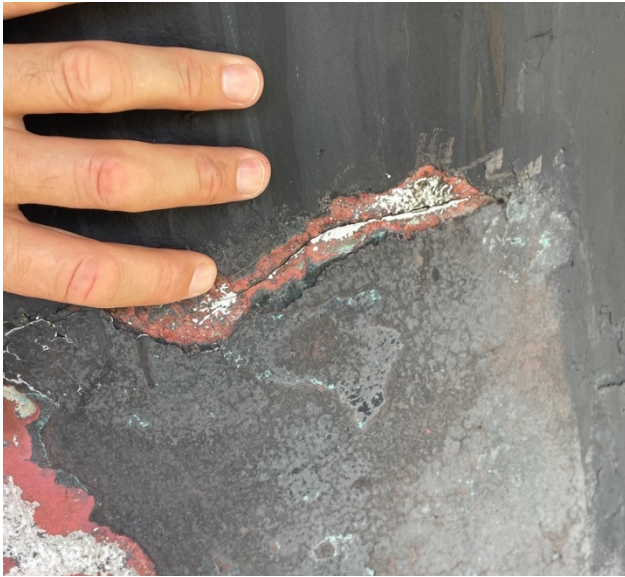
IMG_2516 – Crack at top of fairing, starboard side.

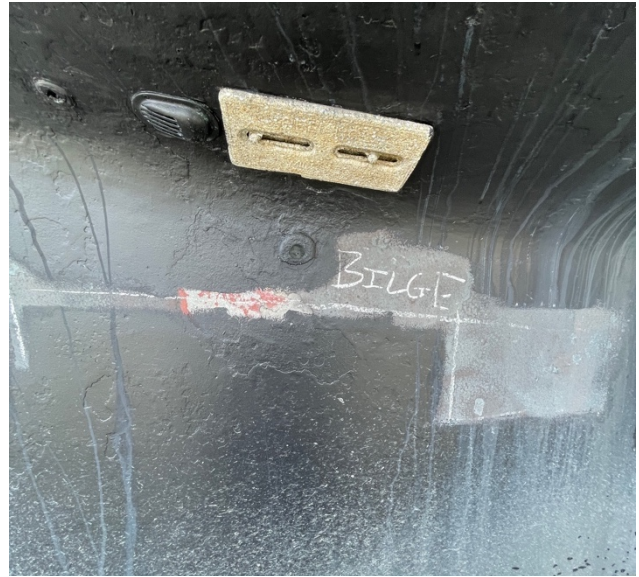
IMG_2517 – Starboard keel side, area of concern outlined in chalk, bilge area marked, damaged transducer and plate zinc.

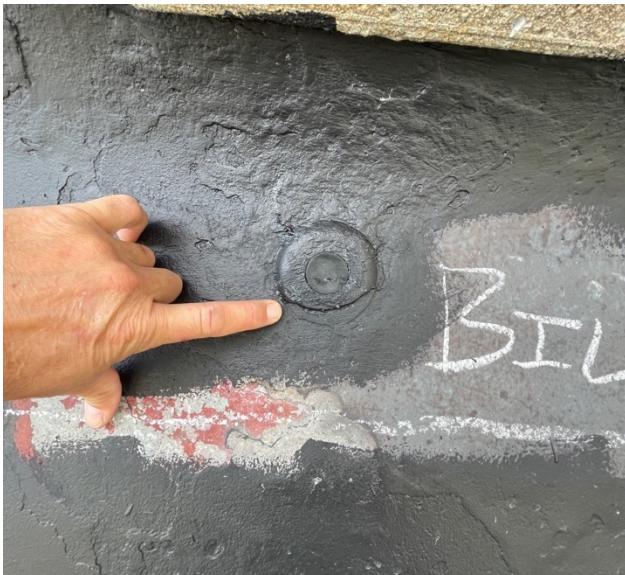
- Underwater metals continuity test was spot checked at the exterior thru-hulls, inconclusive as connections at the interior were not complete.
- Speed transducer at starboard keel side was damaged, missing the lower portion of the flange, **(See Recommendations B15)**.

IMG_2521 – Transducer damaged.

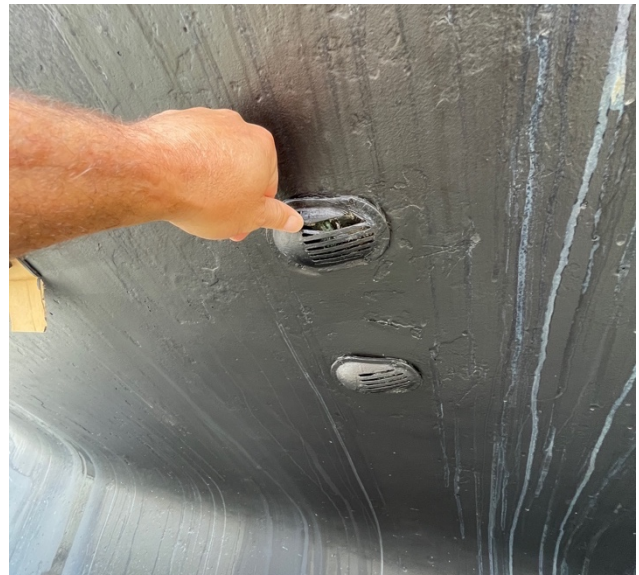
- Thru-hull scoop strainers appeared to be plastic, one was damaged at starboard forward hull side **(See Recommendations B14)**.
- Thru-hull fittings and ball valves were reported to have been inspected by the local machine shop and several had been renewed. Thru-hulls were inspected at the interior. Green wire bonding system was noted to be partially installed, not attached at all thru-hulls, new and existing. New thru-hulls were noted in the forward main saloon starboard bilge space. One new thru-hull was noted in the master aft master cabin bilge space to starboard.

IMG_2523 – Scoop damaged.

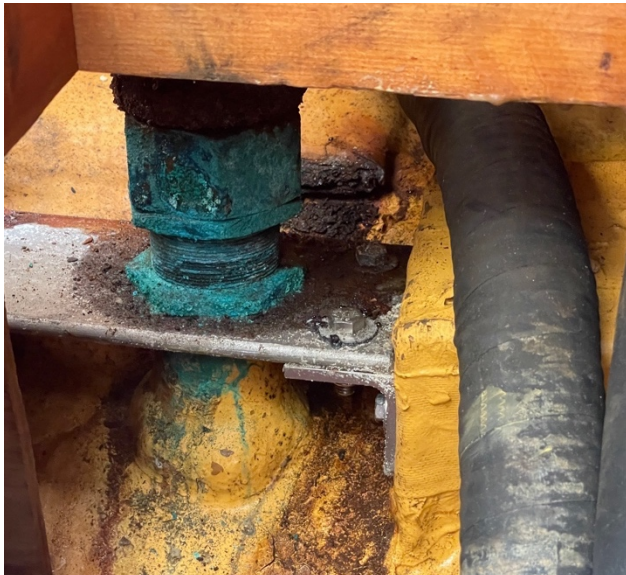
Rudder: Double hung with large aperture, 2-inch stainless-steel rudder shaft, and through bolt mounted shoe with lower bearing. Rudder shaft, packing gland, pitman arm, and hydraulic actuator were sighted below aft cabin bunk hatch access. Rudder shaft was keyed to a stainless-steel pitman arm bolted to a top bearing support above a traditional packing gland. Packing gland showed evidence of weeping (**See Recommendations B1**).

IMG_3479 – Rudder Packing Gland

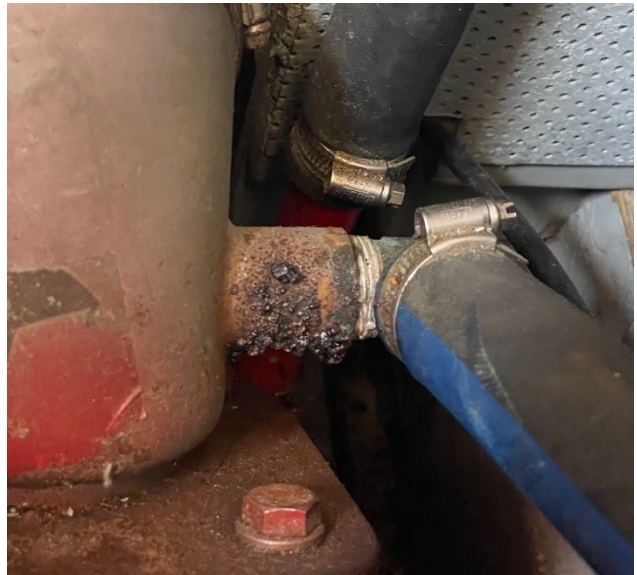
IMG_3511 – Main Engine Exhaust Elbow
Corrosion
