Pre-Purchase Survey

S/Y "Lion's Shade"

44' Nauticat Motorsailer

Condition and Valuation Survey (Pre-Purchase)

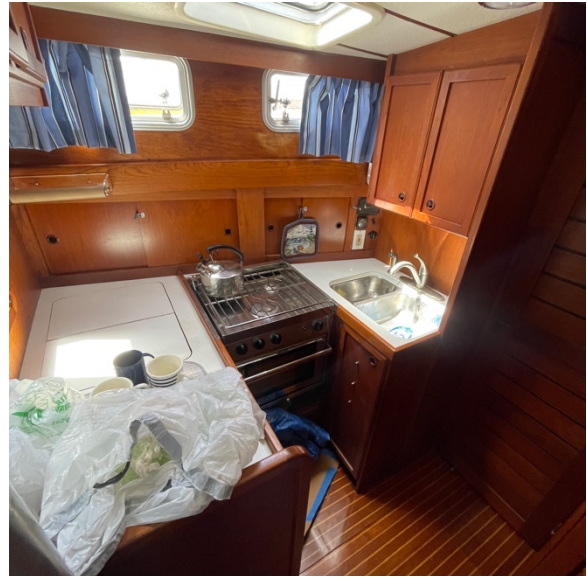
Galley

Galley: Fit aft of the forward cabin to port arranged in U shape with the double basin stainless-steel sink forward, gimbaled three burner stove and oven outboard and counter top space with top opening refrigerator below. Cabinetry spaces for storage were outboard and below the counter top space.
